INSPECTION ORDER FORM

CAPITAL
PROPERTY INSPECTION SERVICE, LLC

General Property Information

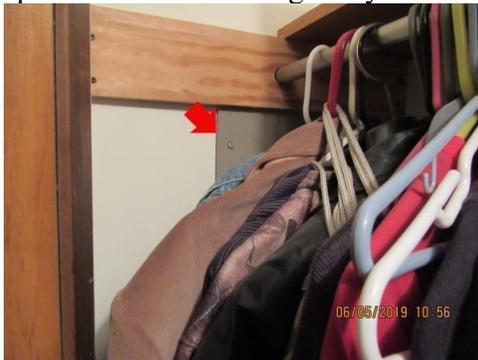
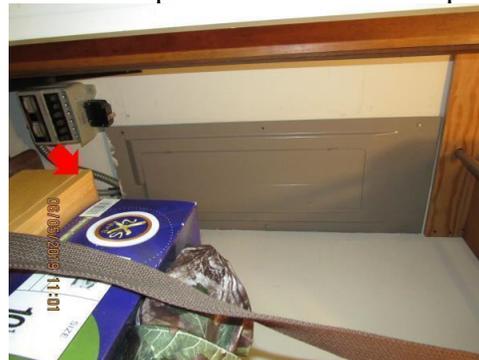
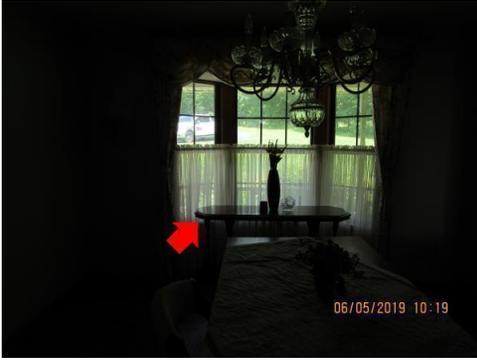
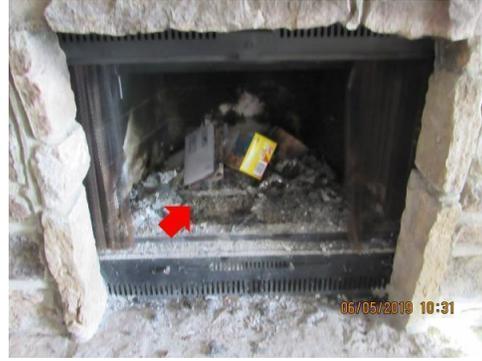
Pictures below reflect limitations due to occupancy:

(Example: furniture or storage may cover microbial growth or inoperative electrical components)

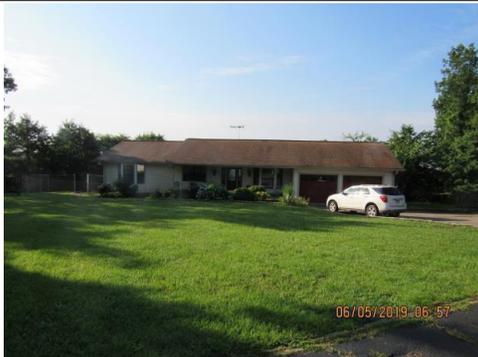
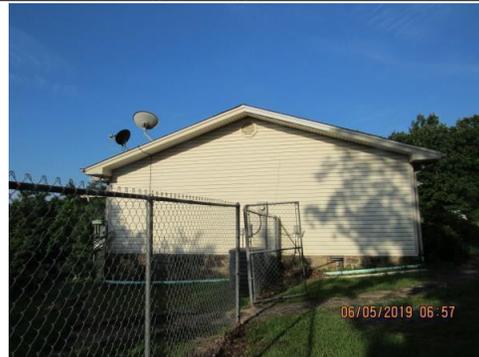
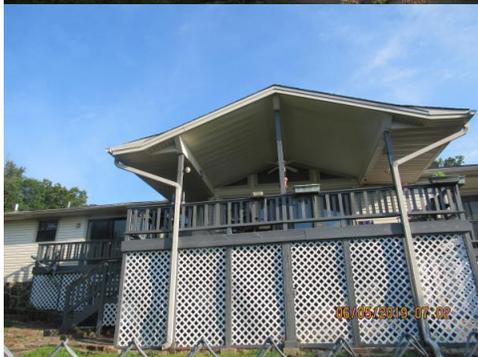
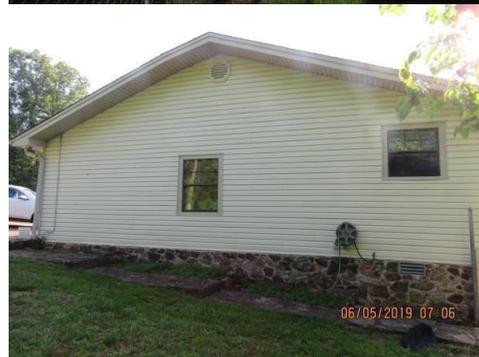
Exterior Walls

Cladding Material:	Vinyl Siding.
Is Aluminum or Steel Siding Grounded?	N/A
Condition of Material:	Appears serviceable. Mildrew stains noted.
Additional Comments:	Aesthetics of home can be improved by pressure washing siding.

10. Recommend repairs to vinyl trim noted on each end of house.
11. Recommend pressure washing exterior of house to remove mildew stains and improve aesthetic appearance of house for sale.

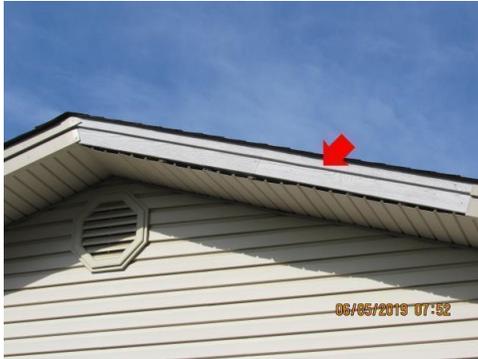
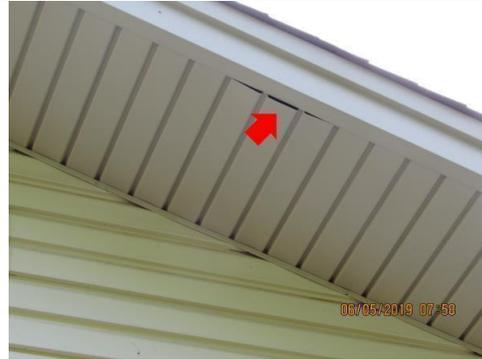
Cladding Material:	Vinyl.
Condition of Material:	Appears serviceable. Damaged trim noted on west and east ends.
Additional Comments:	Trim piece missing on east end of house. Non-matching trim piece installed as repair measure. Soffit hanging down on west end of house.

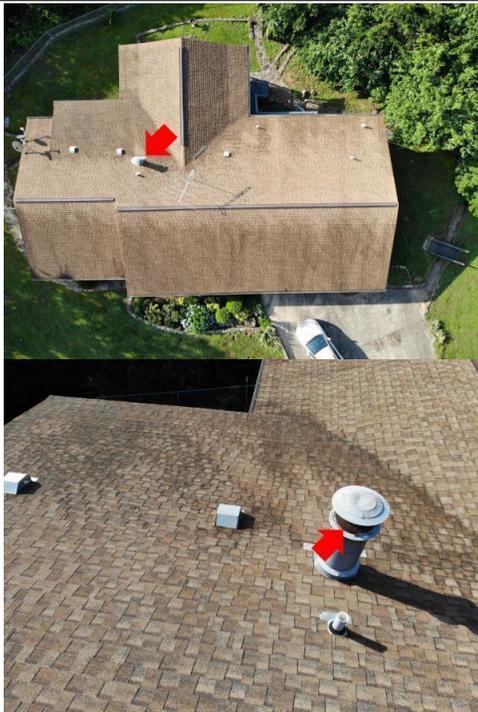
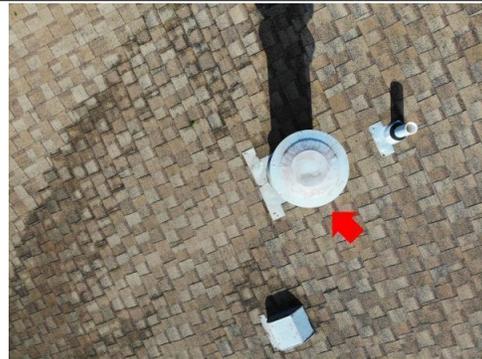
Chimney

Material:	Metal.
Condition of Material:	Appears serviceable. Spark arrester in place.
Additional Comments:	Recommend flue be cleaned and inspected by a professional chimney sweep before being placed in use for the next heating season.

18. Recommend having a professional chimney sweep clean and inspect wood burning fireplace and flue before operating for next heating season.
19. Recommend having a licensed professional structural engineer evaluate roof framing and recommend any additional roof support that might be required to replace bowed struts. If structural improvements are required, make these improvements in conjunction with roof and gutter replacement.

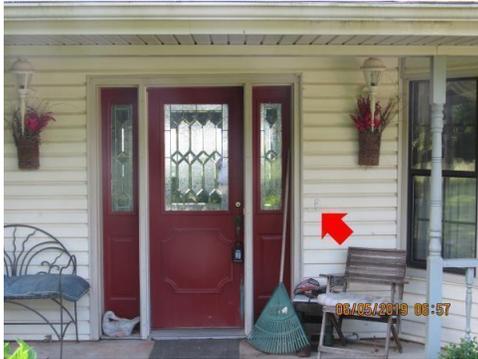
Exterior Door (Main)

Main Entry Door Material:	Wood and glass
Door Material Condition:	Appears serviceable. Door bell appears serviceable. No storm door.

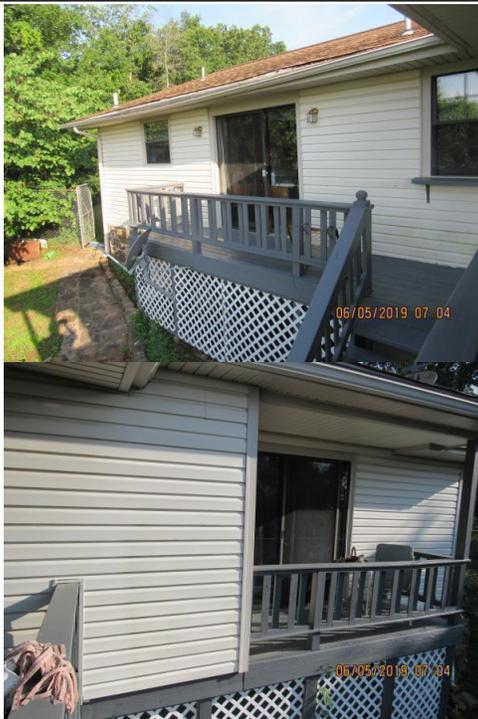
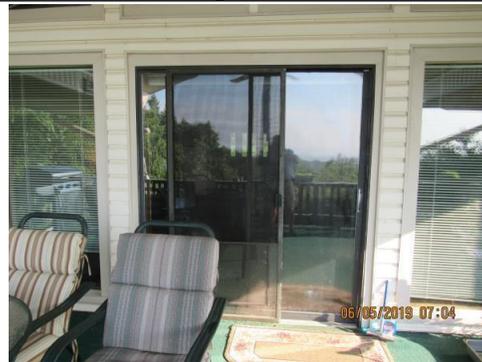
Exterior Door (Other)

Other Entry Door Material:	Metal and glass.
Door Type:	Sliding glass doors. Screen door installed.
Door Material Condition:	Appears serviceable. No door bell.
Additional Comments:	Opened all three exterior rear doors. Glass appears to be double pane.

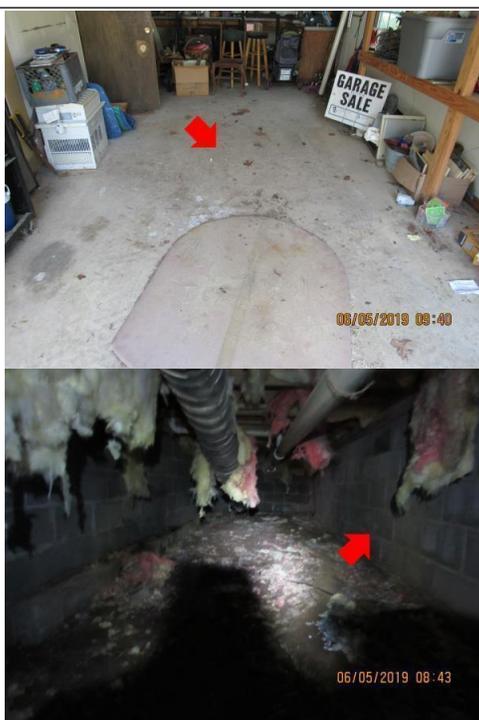
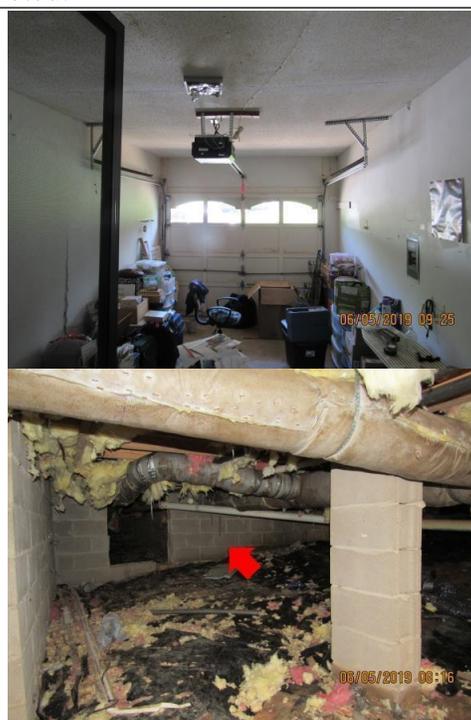
Foundation

Slab on Grade:	Garage floor is slab on fill contained by stem wall observed in crawlspace.. Typical cracks
----------------	---

are noted.

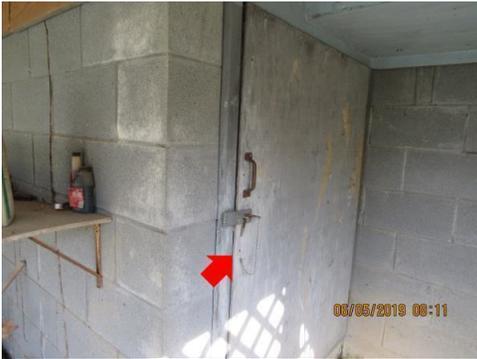
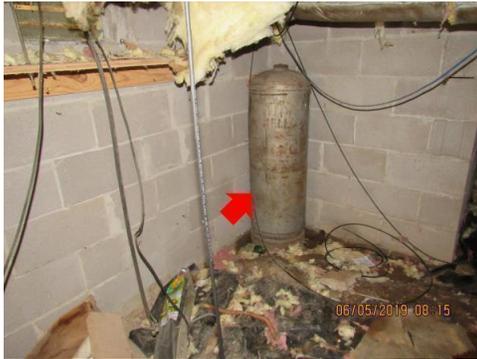
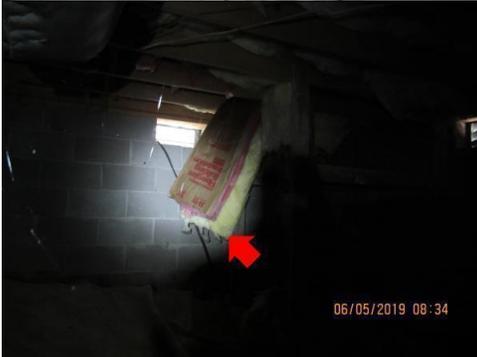
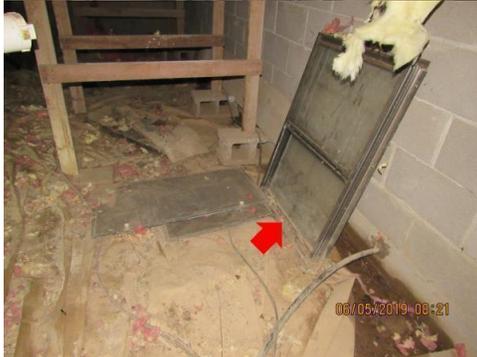
How Inspected:	Visually inspected the crawlspace.
Condition:	Entered crawlspace at door under rear deck. Crawlspace fully accessible.
Foundation Material Type:	Concrete blocks. Stone veneer over blocks on front and each end of house.
Foundation Material Condition:	Visually inspected foundation material. Appears serviceable. Minor cracks not significant at this time, monitor. Ventilation appears serviceable.
Sub Floor Material:	Plywood.
Sub Floor Material Condition:	Floor insulation restricts viewing. Floor insulation has become detached in some locations.
Beams Material:	Dimensional lumber.
Beams Material Condition:	Visually inspected beams. Appears serviceable. Floors insulated.
Floor Joist Material:	Dimensional lumber.
Floor Joist Condition:	Visually inspected joists. Appears serviceable. Floors insulated. Floor insulation restricts viewing.
Additional Comments:	Most floor vents were open at time of inspection. Recommend removing discarded building materials and debris from under

crawlspace. What is purpose of steel cylinder noted?

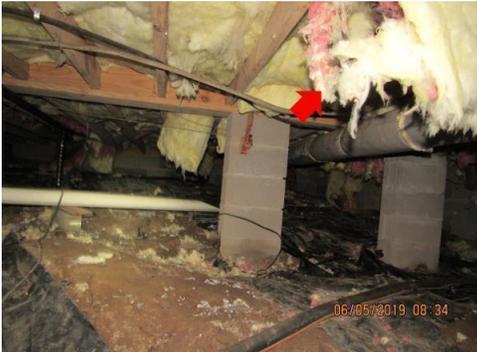
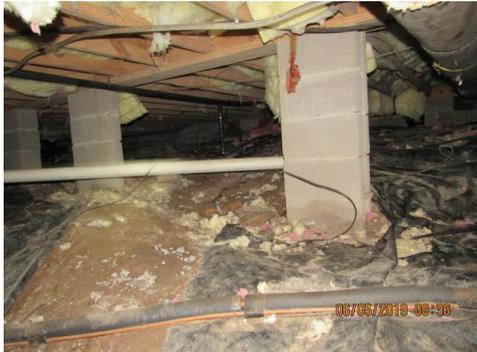
Piers/Columns/Supports Material:	Concrete Blocks.
Piers/Columns/Supports Material Condition:	Visually inspected piers/columns/supports. Conditions appear serviceable.
Additional Comments:	What is purpose of wood floor support added under area of master bedroom?

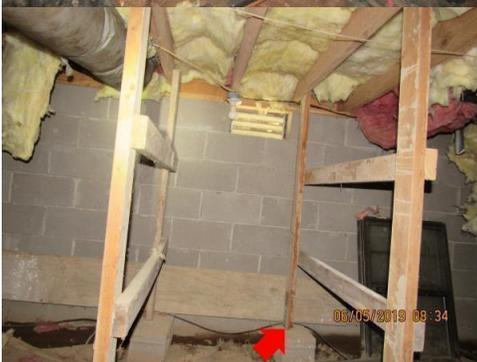
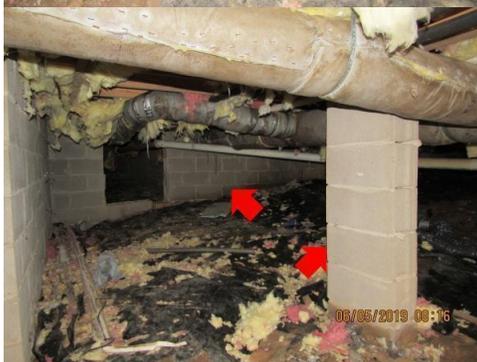
Basement/Crawlspace Drainage:	Appears serviceable. Crawlspace area damp, but no indication of water intrusion. Most of crawlspace floor is covered by plastic vapor barrier.
Additional Comments:	Condensation water is forming on furnace unit and dripping onto crawlspace floor. Rodent droppings indicate that there has been or may be a vermin problem.

1. Rodent scat in crawlspace indicates a past or present vermin problem. If rodents have been exterminated, recommend removing waste evidence. If rodent problem is active, recommend having an exterminator suggest a treatment plan to correct rodent problem.

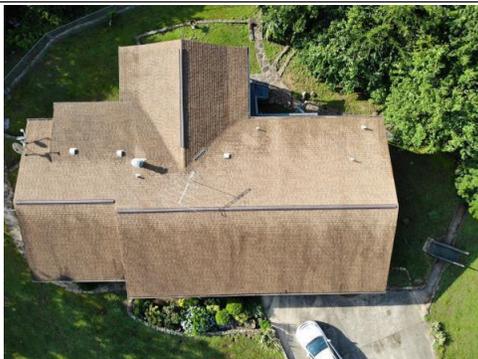
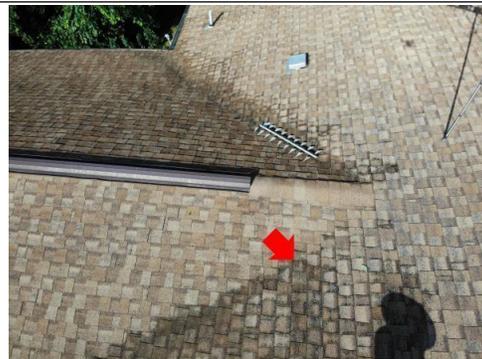
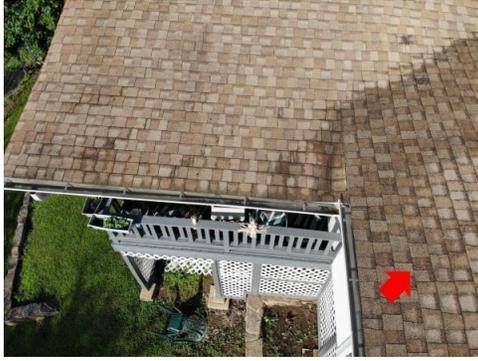
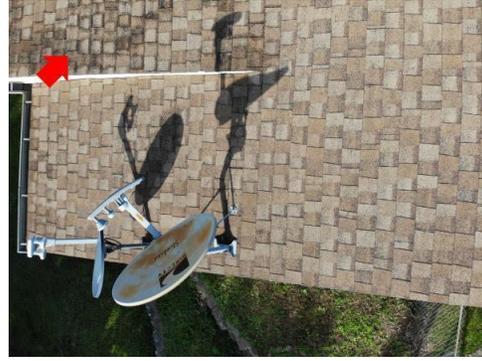
Inspection Method:	Aerial inspection using DJI Mavic Air drone and inspected from ground with Nikon Acculon A211 16x50 binoculars.
Roof Limitations:	None.
Additional Comments:	Walking on roof voids some roofing material manufacturer's warranties. Also, walking on roof can damage roofing material that may be near the end of its useful service life.
Roof Style:	Gable. 2 in 12 to 4 in 12.
Roof Covering:	Asphalt Shingles (Architectural).
Roof Covering Condition:	Appears to be near end of useful life. Anticipate the need to replace in near future. Note loss of granules on shingles indicating age.
Additional Comments:	Seller states that roof has sustained past hail damage. Seller states that he plans to replace the existing roofing material with new roof as part of real estate transaction.

6. Recommend securing floor insulation as required that has fallen down in crawlspace.
7. Recommend roof and gutter repair or replacement.
8. Provide buyer information on operation of two exterior water faucets that are cut off.

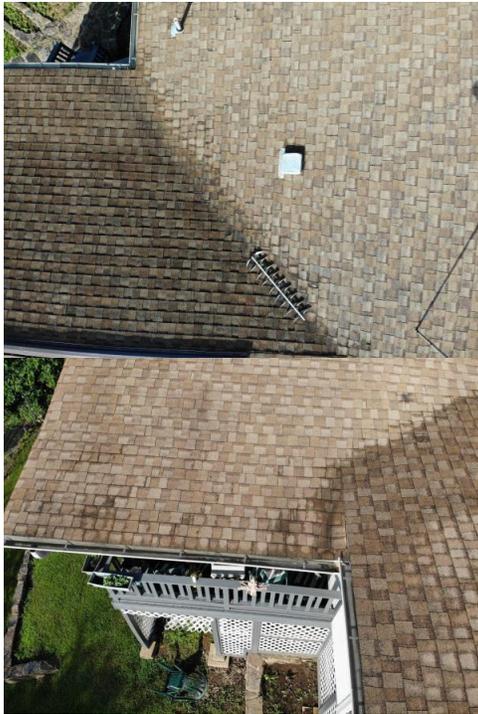
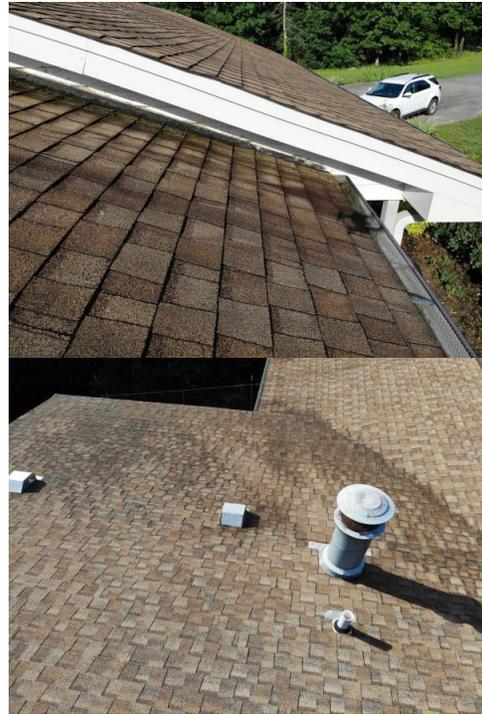
Flashing Material:	Unable to identify.
Flashing Material Condition:	Appears serviceable.
Additional Comments:	Roof appears to be near end of useful service life and according to seller has sustained hail damage in the past. Seller plans to install new roof before sale. Valley flashing is fully woven closed valley pattern.

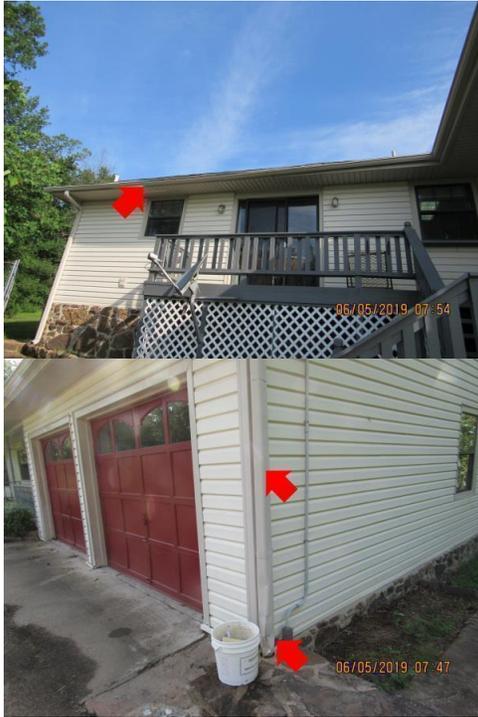
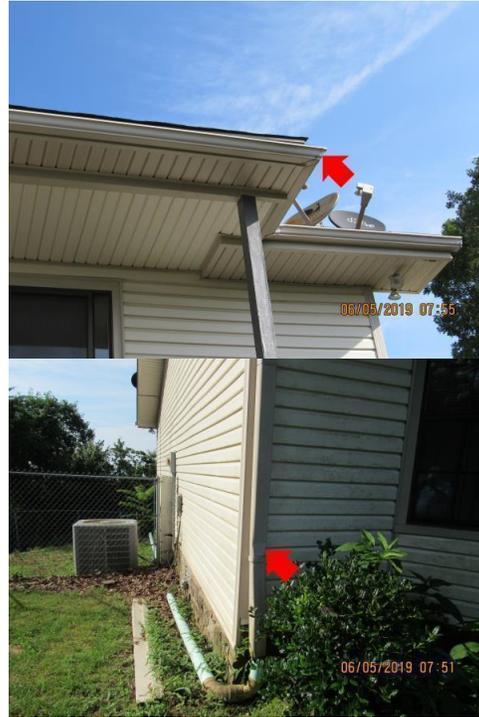
Gutter Material:	Metal.
Gutters Condition:	Full gutters. Front gutters appear serviceable.

Rear gutter is sagging and may be detached from house on west end. Rear gutter gutter sags on east corner Downspouts all have some degree of damage.
Additional Comments:	Gutters appear clean and are covered by guttergard material.

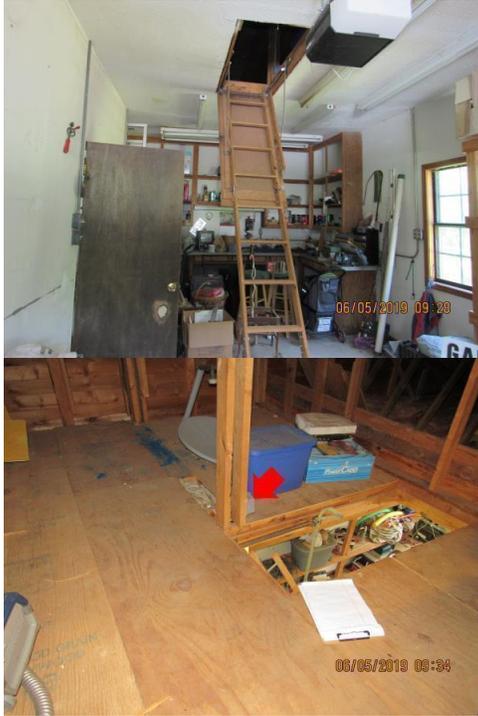
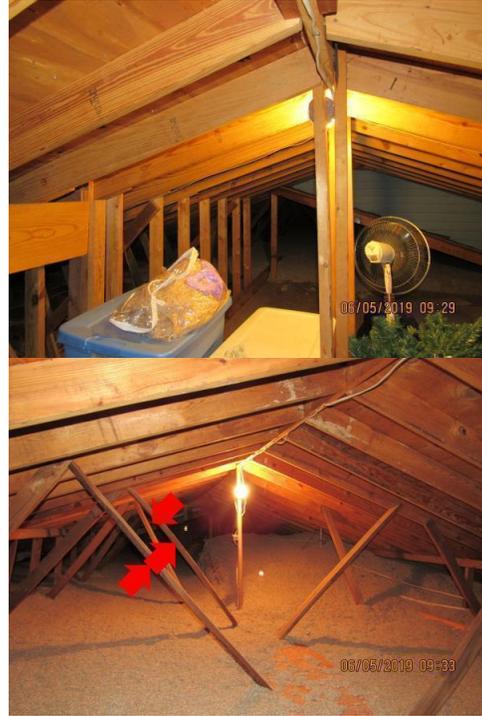
Attic - How Inspected:	Attic was accessed via access steps garage interior.
Roof Structure:	Attic is full size. Conventional framing. Roof sheathing plywood.
Framing Member Dimensions:	2x4 and 2x6
Attic - Stairs:	Appears serviceable. Pull down staircase has some minor obstructions, but can be lowered.
Attic Hatch:	Appears serviceable.
Attic Condition:	Appears serviceable. Ventilation is provided via ridge vent/gable vent/vented soffits.
Additional Comments:	Attic appears to have had some struts added for additional structural support and struts appear to be bowed. Consider having a structural engineer evaluate roof framing structure.

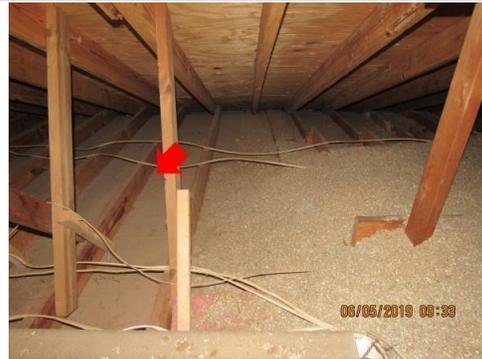
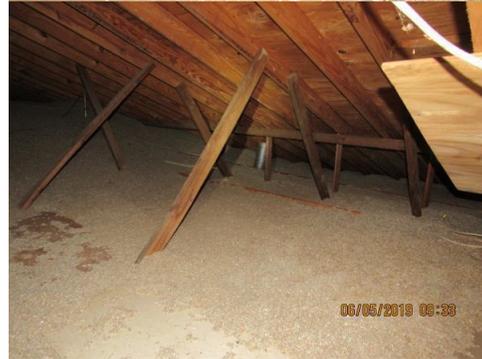
Insulation (Attic)

Attic Insulation Material:	Cellulose blown.
Attic Insulation Condition:	Appears adequate. No insulation over garage area.
Depth of Insulation:	Not determined. Estimate 8-10 inches.

20. Recommend adding ceiling insulation over garage area.

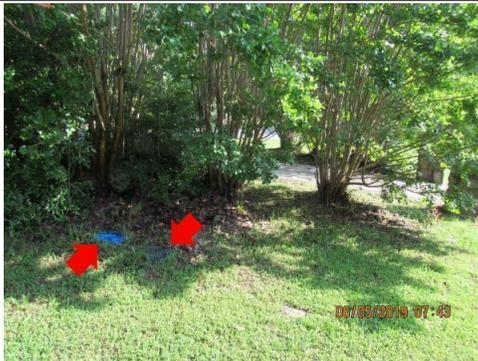
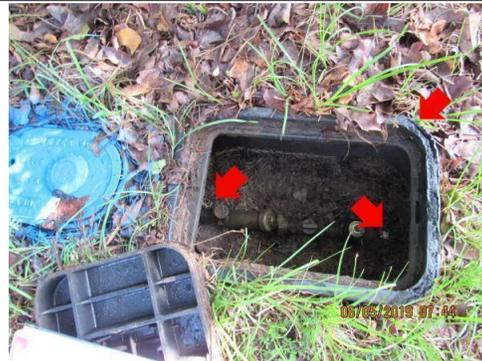
Main Water Line

Main Line Material:	Not determined.
Main Line Service Condition:	Water meter location is front of lot and west of stone column
Additional Comments:	Water line from meter to cutoff valve appears to be galvanized steel. Water line from cutoff valve to house appears to be PVC plastic.

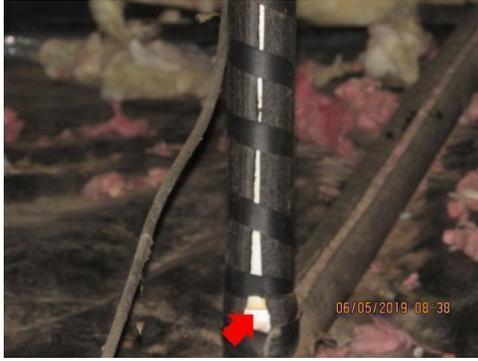
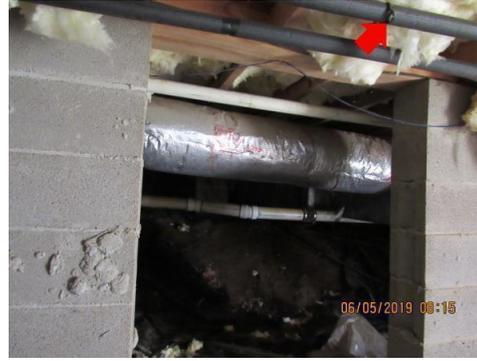
Supply Line Material:	Plastic and copper under the house.
Supply Line Condition:	Appears serviceable.
Additional Comments:	Water pipes in the crawlspace under the house are insulated.

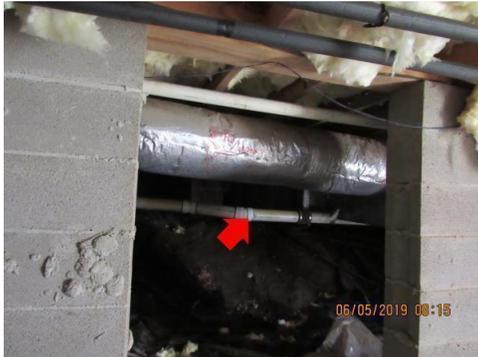
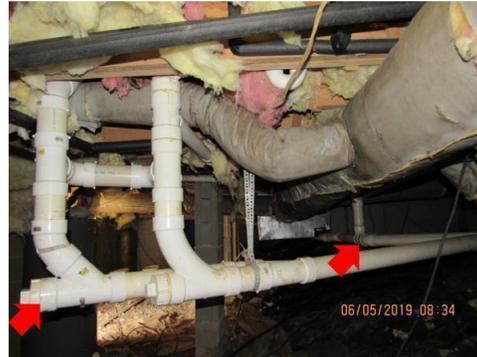
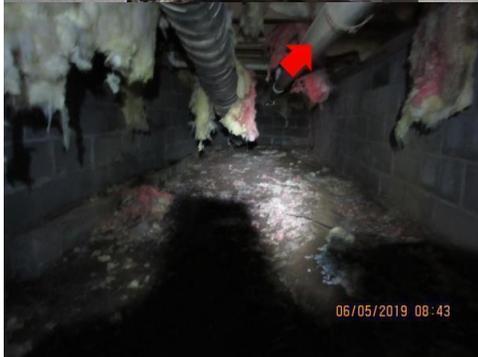
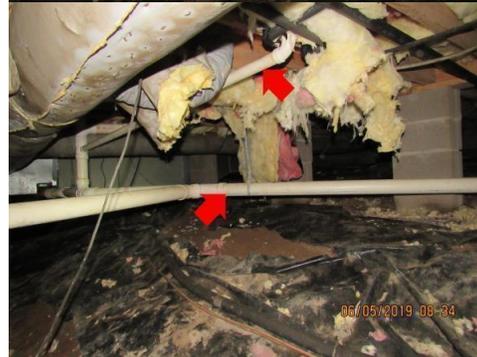
Drain, Waste, and Vent System

Drain and Waste System Material:	PVC plastic.
Drain and Waste System Condition:	Appears serviceable.
Vents System:	Appears serviceable.
Additional Comments:	Drain exits east side of crawlspace to septic tank.

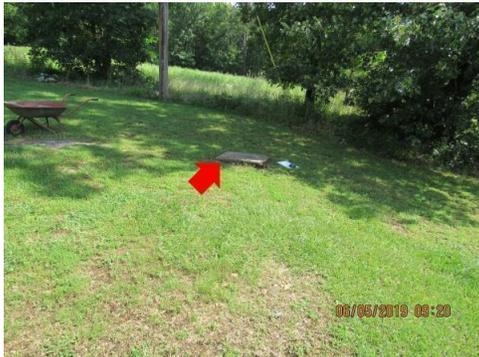
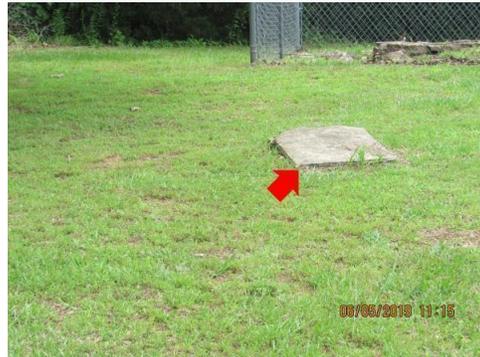
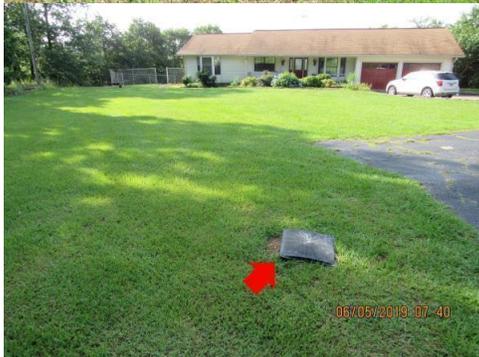
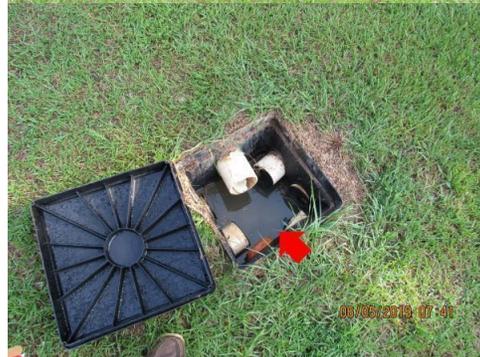
Drainage Ejector/Sump/Pump

Sewer Ejector Pump:	Appears serviceable.
Additional Comments:	Seller should advise buyer of septic tank and ejector pump location under concrete cover. Condition of septic tank and ejector pump may require evaluation by a licensed plumber depending on when the septic tank was last pumped out and cleaned. Distribution box for

septic system is in front of house. Distribution box is upgrade from house and therefore, an ejector pump is required.
--	--

4. Recommend having a licensed plumber add discharge line to pressure relief valve on water heater in crawlspace.
5. Recommend having a licensed plumber assess septic system and recommend any needed service such as pumping septic tank or servicing ejector pump.

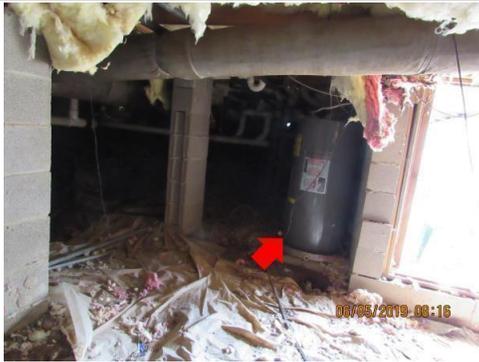
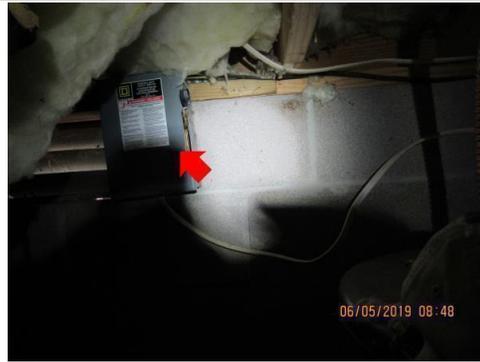
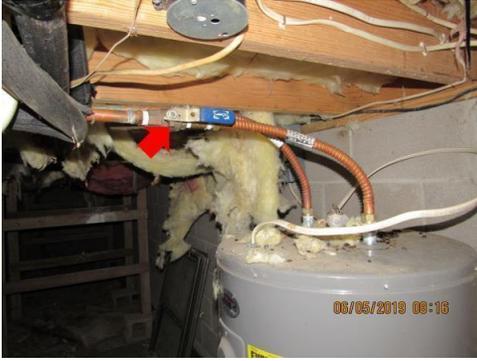
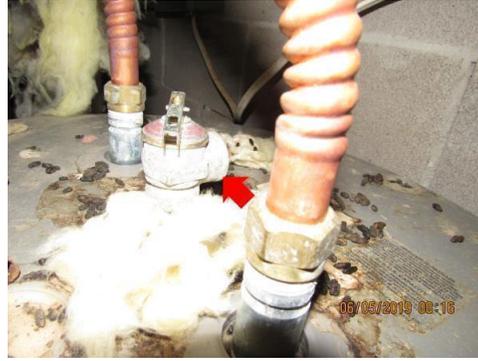
Water Heaters

Water Heater Type (1):	Electrical. Manufacturer: Richmond Serial Number: RM Q271226224 Date of manufacture: July 06, 2012
Water Heater Location:	Crawlspace.
Water Heater Condition:	Appears serviceable. Water shutoff valve is installed. Temperature pressure relief valve noted but not tested. Temperature pressure relief drain line not installed.
Additional Comments:	50 gallon capacity

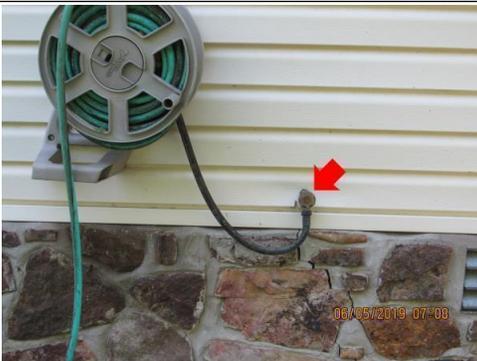
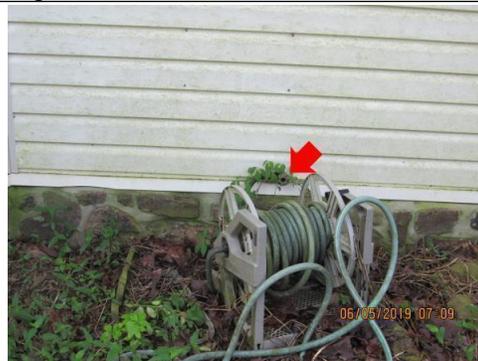
Hose Faucets

<p>Operation:</p>	<p>Faucets are located on west end and in front of house..These faucets appear to be frost proof and were operated. Faucets above deck and below deck are cutoff and no water was discharged. HOSES SHOULD BE DISCONNECTED FROM FAUCETS DURING COLD WEATHER AS THIS MAY CAUSE THEM TO FREEZE.</p>
<p>Additional Comments:</p>	<p>Verify for buyer if two faucets that did not discharge water are cutoff type and require being cutoff during cold weather to prevent freezing.</p>

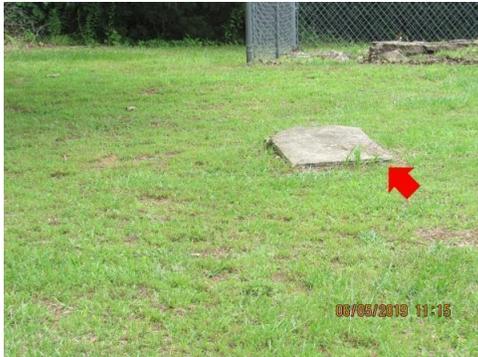
Septic System

Septic/Drain Field Location:	Septic tank is located under the concrete cover on the east side of property. Ejector pump is located inside septic tank .
System Condition:	Appears serviceable.
Additional Comments:	Odor emanates from distribution box when sewage is being pumped.

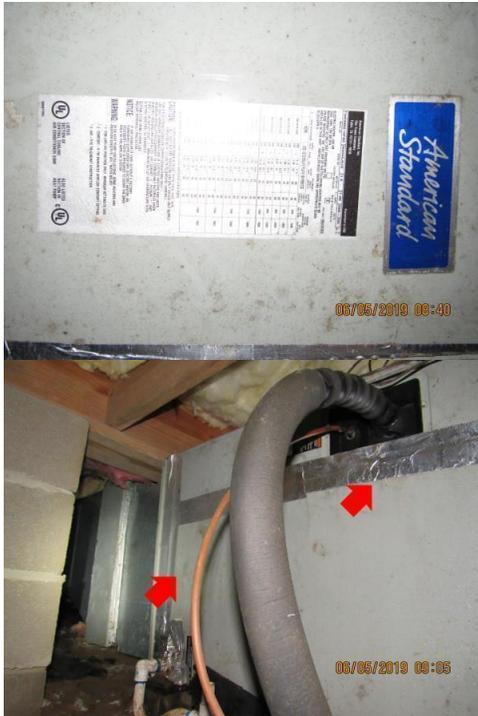
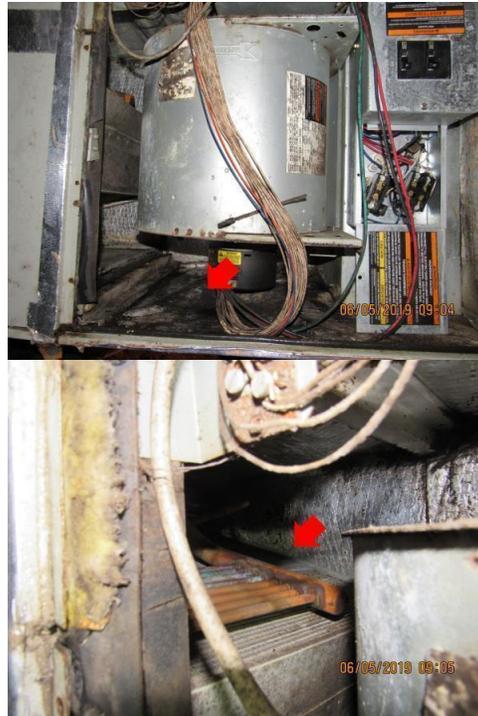
Heating Systems

Heating System Location:	Crawlspace.
Heating System Type:	Heat Pump.
Fuel Type:	Electric.
Capacity of Unit:	BTU: 65,000 determined from model number (065)
Date of Manufacture/Manufacturer:	Manufacturer: American Standard Serial #: R2044J51V Model #: TWE065E13F80 Date of manufacture: May 2000
Condition of Unit:	Appears serviceable.
Blower Fan:	Appears serviceable. Operated during inspection. Fan compartment dirty needs cleaning. Mold appears to be present due to dampness caused by condensation in blower compartment.
Air Plenum:	Appears serviceable.
Thermostat:	Appears serviceable.
Ducts, Registers and Grilles:	Appears serviceable.
Additional Comments:	Recommend evaluation by a licensed HVAC technician to determine if there is a solution to the water condensation problem, has condensation caused any corrosion damage to the furnace unit or electrical controls, does the apparent mold present pose any health hazard? Has mold contaminated ductwork? Condensor compartment was sealed with tape. Did not break seal. Did not operate heat cycle because house was occupied and outdoor temperature was near 90-degrees.

2. Furnace located in crawlspace has a problem with water condensation. Recommend having a licensed HVAC contractor assess situation to recommend corrective measures to be taken, determine if moisture problem has damaged any electrical and control components of system, if apparent mold development poses any health risk and if apparent mold has contaminated ductwork.

3. HVAC system is nineteen (19) years old. Recommend having a licensed HVAC technician evaluate overall condition of system and estimated remaining service life of system.

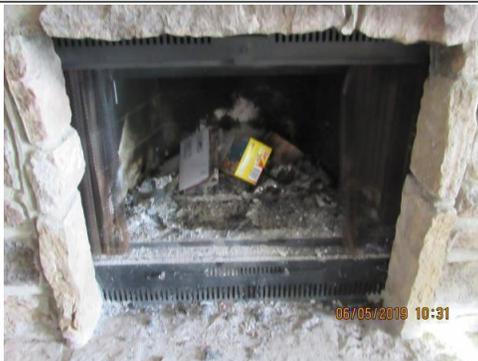
Fireplaces/Space Heaters/Wood Stoves

Location/Description/Condition:	Appliance is prefabricated metal. Appears serviceable. Recommend cleaning and inspection before use.
---------------------------------	--

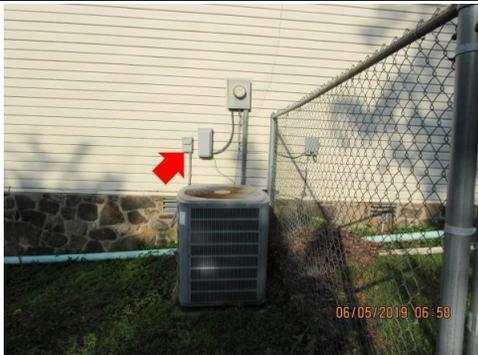
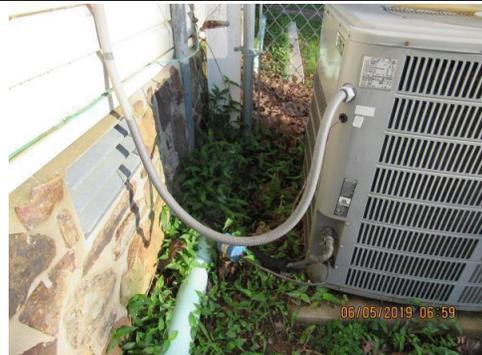
Air Conditioning Description:	Central.
Air Conditioning Power Source:	220.
Date of Manufacture/Manufacturer:	Manufacturer: American Standard . Serial #: R0852911F Model #: 6H4042B100A0 . Date of manufacture: February 2000
Size of Unit:	Tons. 3.5 as determined from model number (42)
Return Air Temperature:	67.2-degrees
Air Temperature Drop:	7.5-degrees

System Condition:	Appears serviceable. Electric disconnect provided as required. Electric disconnect within site of unit. Unit was operating at the time of inspection.
Condensate Line:	Present.
Attic Fan:	N/A
Swamp Cooler:	N/A
Additional Comments:	Recommend having a licensed HVAC technician evaluate HVAC system due to age (19 years).

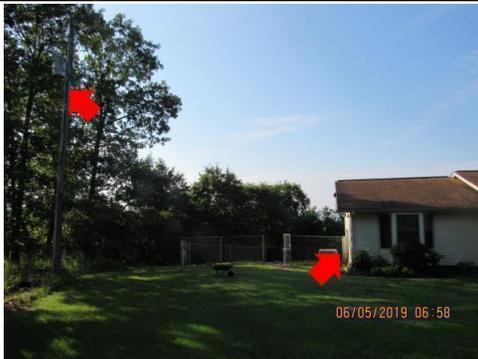
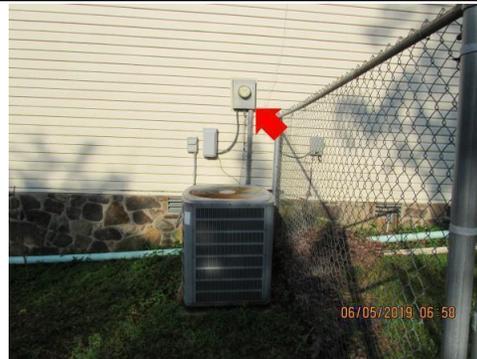
Service Drop and Entrance Type:	Underground. 110/220 Volt.
Service Drop and Entrance Condition:	Appears serviceable.

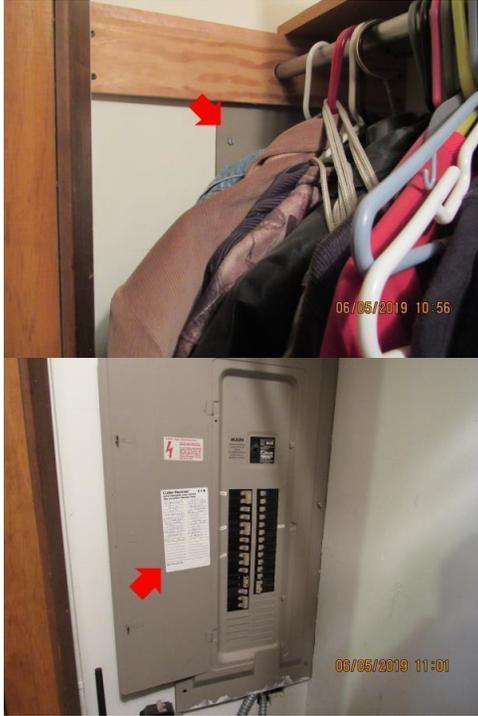
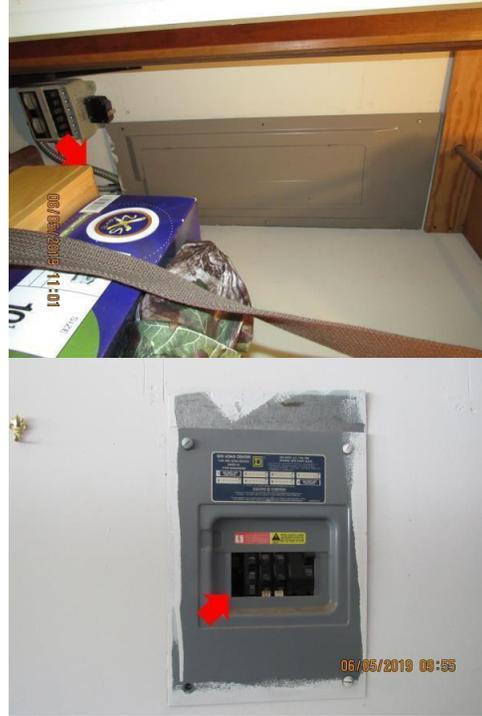
Electrical Panels

Panel Location:	Closet bedroom #2
Panel Condition:	Panel condition could not be determined because access to remove panel cover was obstructed by chest of drawers in closet.
Number of 110 Circuits:	18
Number of 220 Circuits:	6
(1) Sub Panel Location:	Garage. No panel cover and one circuit breaker panel cover is missing.
(2) Sub Panel Location:	Crawlspace. Panel cuts power to water heater.
Additional Comments:	Recommend having a licensed electrician evaluate complete electrical system.

12. Recommend having a licensed electrician evaluate electrical system, make corrections noted on subpanel box in garage, check electrical outlet in great room that will not receive an electrical plug, and upgrade exterior electrical outlets and electrical outlets over bathroom vanities and kitchen counter to GFCI outlets to comply with current electrical codes and standards.

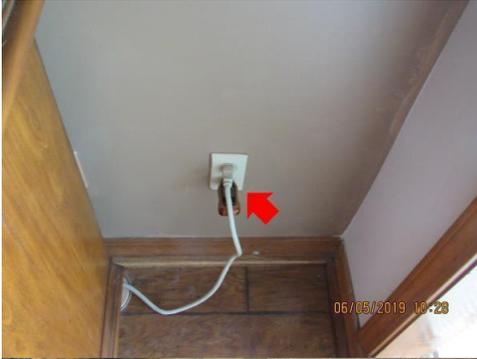
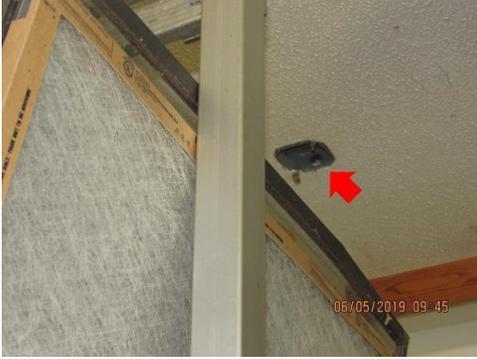
Distribution System and Components

Entrance Cable:	Not determined. Could not remove electric panel box cover due to obstruction.
Branch Wiring:	Not determined. Could not remove electric panel box cover due to obstruction.
Switches and Outlet Condition:	Appears serviceable.
Additional Comments:	Test device could not be plugged into electric outlet on east wall of greatroom near sliding glass. Attic light fixture needs to be closed. Light fixture in east side of garage needs cover. Junction box in west side of garage needs cover. Light fixture in crawlspace has a partially open junction box. Exterior electric outlets and interior electric outlets over bathroom vanities and near kitchen sink are not GFCI. GFCI outlets may not have been required at time of construction, but replacement with GFCI outlets is recommended.

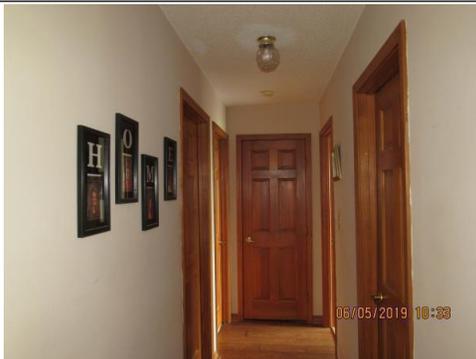
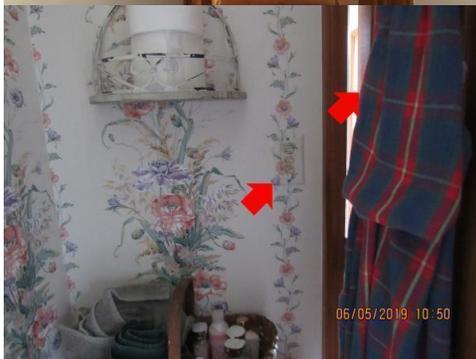
Interior Doors

Interior Door Condition:	Appears serviceable. Door in master bathroom installed backwards and hides electrical switches.
Additional Comments:	Interior doors are wood.

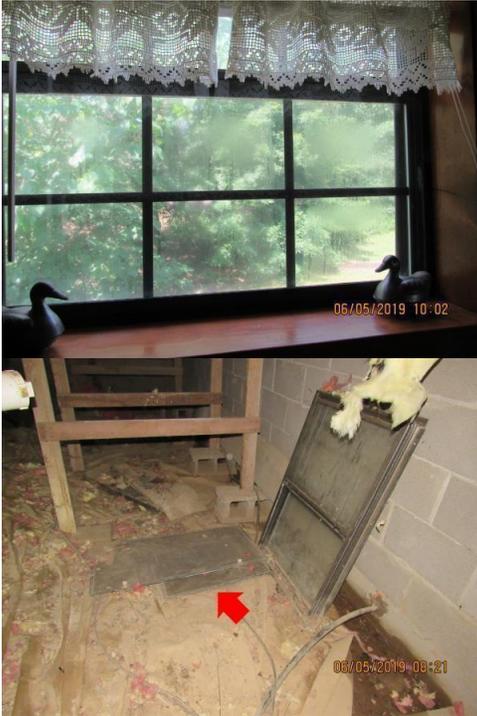
Window Type:	Aluminum. Insulated glass.
Window Condition:	Appears serviceable. Some screens missing. Storm windows installed.
Additional Comments:	Windows appear to have single pane storm window inside of insulated double pane windows. I did not remove storm window to access exterior window to operate. Front bay

window missing screens, There are some window screens in crawlspace that may be missing window screens.

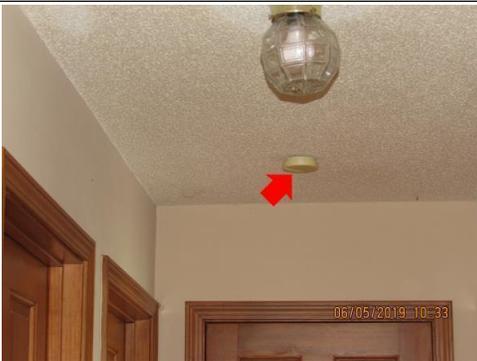
Smoke Detectors Comments:	Appears serviceable. No carbon monoxide detector noted.
Additional Comments:	One smoke detector observed and located in hallway.

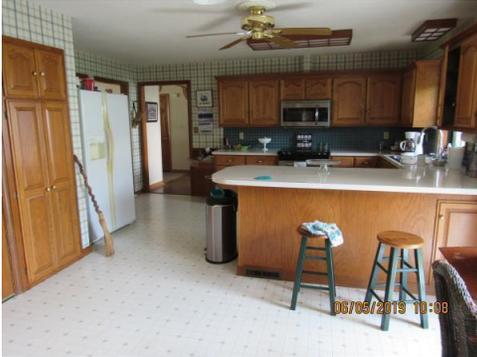
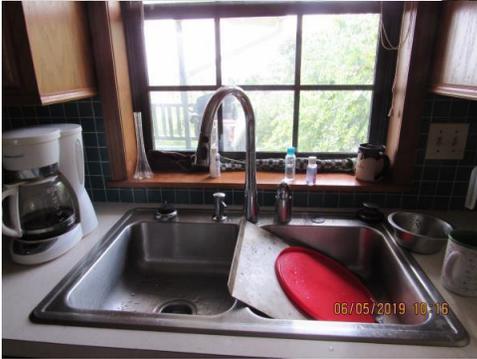
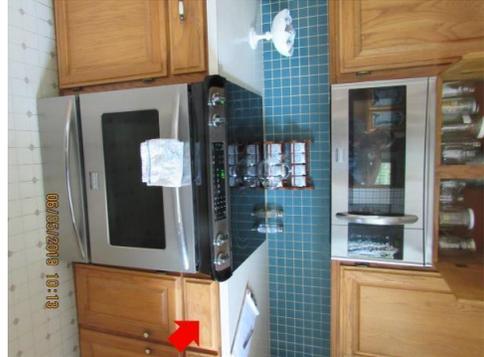
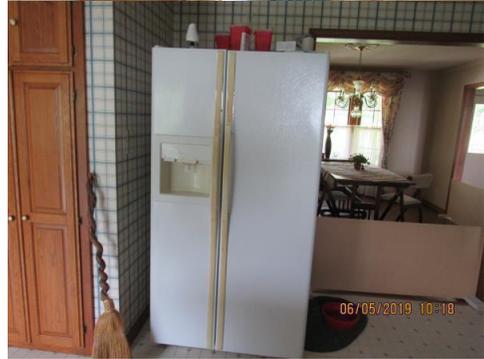
Kitchen Sink Type and Condition:	Stainless Steel. Appears serviceable. Faucet appears serviceable. Hand sprayer appears serviceable.
Garbage Disposal:	Appears serviceable, but noisy. Needs evaluation by licensed plumber to determine if repair or replacement is required..
Kitchen Range:	Electric. Free standing. Appears serviceable. Manufacturer: Frigidaire
Microwave:	Appears serviceable. Microwave is a combination microwave oven / convection oven. Manufacturer: Frigidaire
Ventilation:	External. Vent appears serviceable.
Refrigerator:	Appears serviceable. Manufacturer: General Electric
Ice Maker:	Make inquiry with home owner to determine if ice maker is operational. No ice in bin at time of inspection and ice trays in freezer.
Dish Washer:	None installed.
Trash Compactor:	None installed.
On-Demand Hot Water Dispenser:	None installed.
Counter Tops Type and Condition:	Formica. (Plastic Lament). Appears serviceable.

Cabinets Condition:	Appears serviceable. Handle missing from drawer to right of oven.
Laundry/Utility Room Location:	Located on main floor off kitchen.
Laundry/Utility Room Condition:	Plumbing appears serviceable. 220 volts provided and appears serviceable. Dryer vent observed outside. Could not see dryer vent hose behind dryer. Confirm dryer vent with seller. Washer and dryer are Whirlpool.

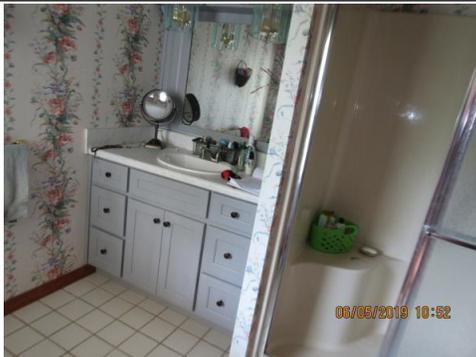
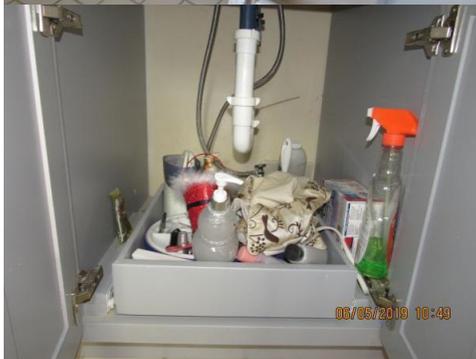
Bathroom Location (1):	Master bedroom.
Sink Condition:	Appears serviceable. Drain appears serviceable.
Vanity Condition:	Vanity appears serviceable.
Commode Condition:	Appears serviceable. Tank/bowl connection is loose requires tightening.
Tub and Shower Area:	Shower unit only. Appears serviceable. Drain appears serviceable. Shower head appears serviceable. Tub/shower walls appear serviceable.
Ventilation System:	Appears serviceable.
Additional Comments:	Electrical outlets over vanity are not GFCI.

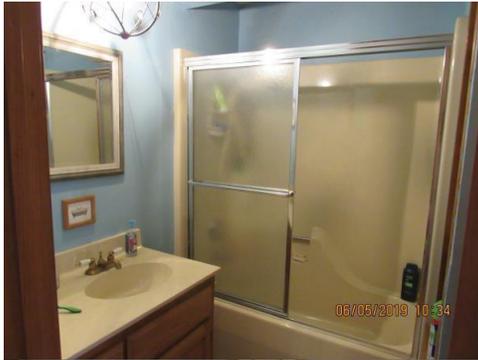
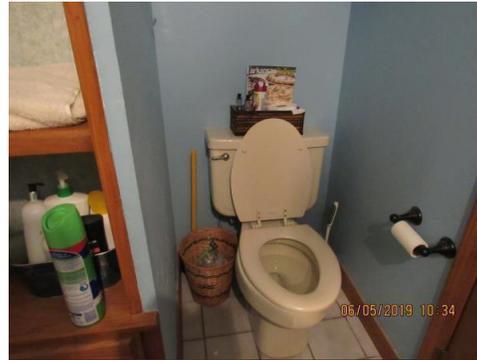
Bathroom Location (2):	Hall.
Sink Condition:	Appears serviceable. Drain stopper inoperative.
Vanity Condition:	Vanity appears serviceable.
Commode Condition:	Appears serviceable. Tank/bowl connection is loose requires tightening.

Tub and Shower Area:	Tub and shower are same unit. Appears serviceable. Drain appears serviceable. Shower head appears serviceable. Tub/shower walls appear serviceable.
Ventilation System:	Appears serviceable.
Additional Comments:	electrical outlets over vanity are not GFCi.

9. Recommend having a licensed plumber make bathroom repairs to tighten toilet tank to toilet bowl in master bathroom and hall bathroom and repair sink stopper that is not connected in hall bathroom.

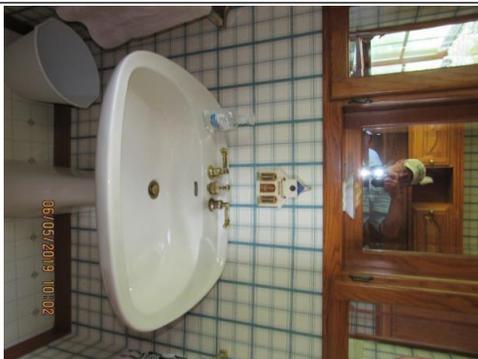
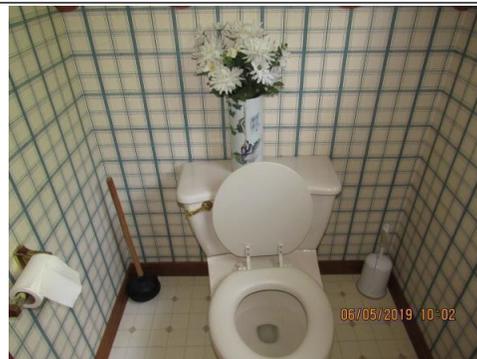
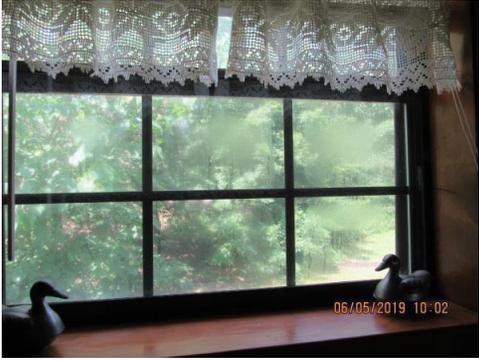
Bathroom Location (3):	Laundry or mud room.
Sink Condition:	Appears serviceable. Drain appears serviceable.
Vanity Condition:	Vanity appears serviceable.
Commode Condition:	Appears serviceable.
Tub and Shower Area:	N/A
Ventilation System:	Vent fan is inoperative replacement required.
Additional Comments:	Bathroom 3 is a half bath.

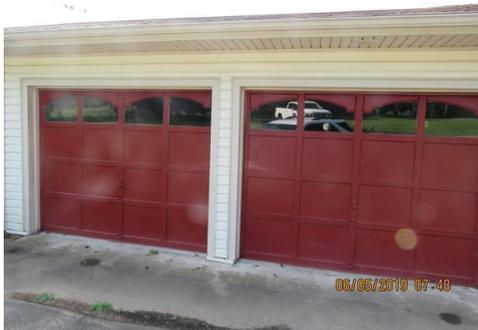
Type:	Garage.
Location:	Attached.
Roof Condition:	Same as house.
Floor Condition:	Appears serviceable. Typical cracks noted.
Garage Doors Condition:	Appears serviceable. Automatic door opener operational. No infrared eyes or safety stop on garage doors.
Additional Comments:	Two car garage has a partition wall between each parking side.

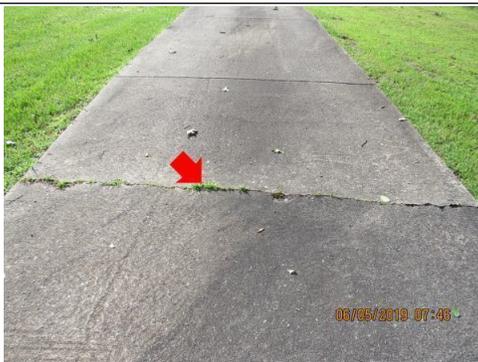
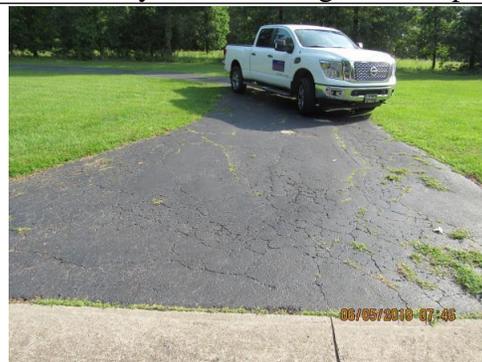
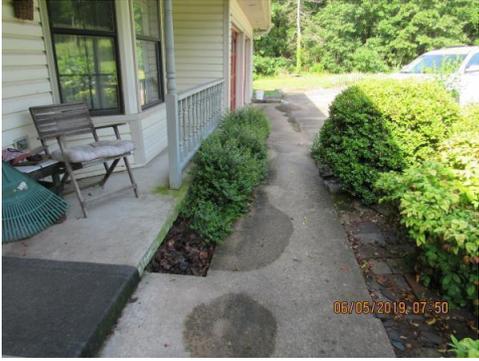
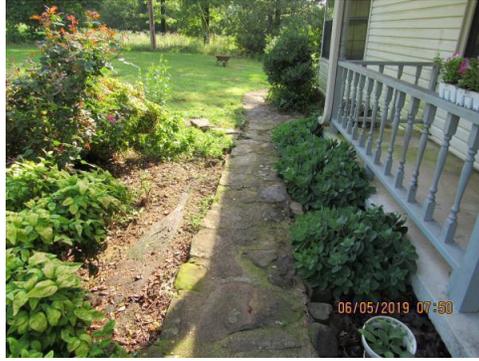
Driveway:	Driveway is concrete. Appears serviceable. Typical cracks noted.
Sidewalks:	Sidewalk is concrete and stone.
Landscaping:	Landscaping is maintained.
Retaining Walls Type and Condition:	Masonry. Appears serviceable.
Site Grading:	General slope. Drainage appears to be adequate.
Porch/Cover Type and Condition:	Same as house.
Patio/Decks Type and Condition:	Deck is wood. Floor is carpeted which restricts viewing. Handrails/guardrails appear serviceable. Exterior stairs appears serviceable.
Fences and Gates Type and Condition:	Chain link. Appears serviceable. Gate appears serviceable.
Additional Comments:	Fence gate drags. Stone steps on east end of house have a 9" rise. Standard rise for steps is 8". Caution buyer about using these steps.
